REGISTRATION PROBLEM WORKSHEET

If you begin having problems with the Micro-Registration Heads not staying in alignment, you need to check each Micro-Registration Head for proper adjustment. The adjustments are as follows:

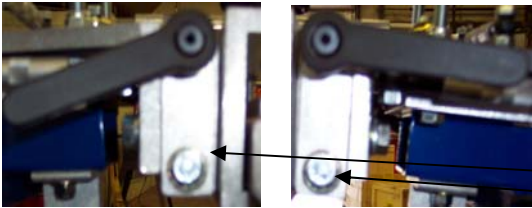
STEP 03:

The Tilt Block retaining bolts, located below the "Long" handle on the Left and Right side of the Micro-Registration Head, must be firm but not too tight. If too tight, the Screen Tilt will not work. If too loose, the registration could move during operation.
